SX1

Level 2.5

Repair Documentation

V 1.0

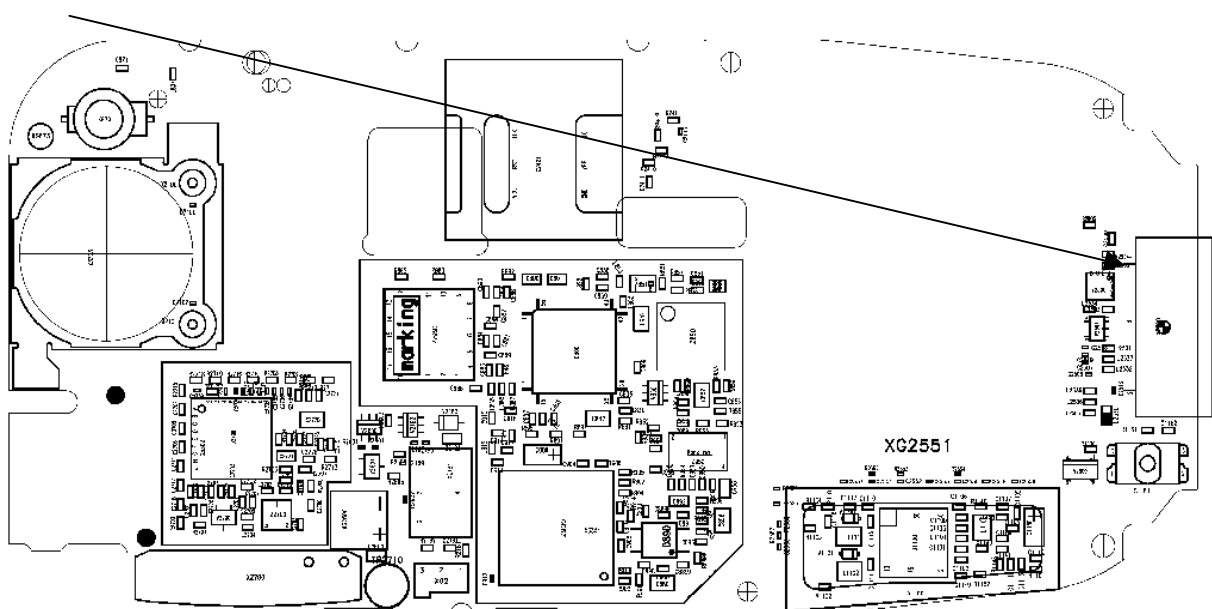
Figure 1: SX1 board I/O connector

- Charging problems.
- Problems with external loudspeaker or microphone when using a car kit.
- Problems with accessories connected at the I/O - connector.
- Problems with SW booting

Visually check the bottom connector. Watch for oxidation and dry solder joints.

Use hot air blower remove defective I/O connector.

Resolder new I/O connector afterwards.

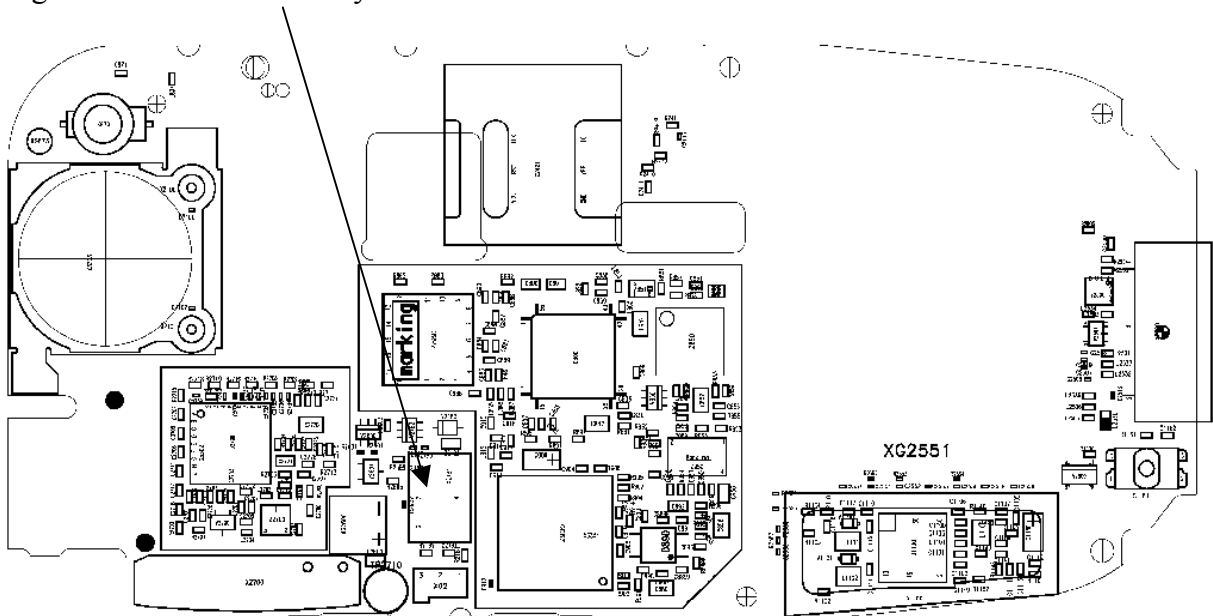
Figure 1: SX1 board Battery connector

- Mobile does not switch on.
- Error message "WRONG BATTERY" on display.

Visually check the status of the Battery connector. Watch for oxidation and dry solder joints.

Use hot air blower remove defective Battery connector.

Resolder new Battery connector afterwards.

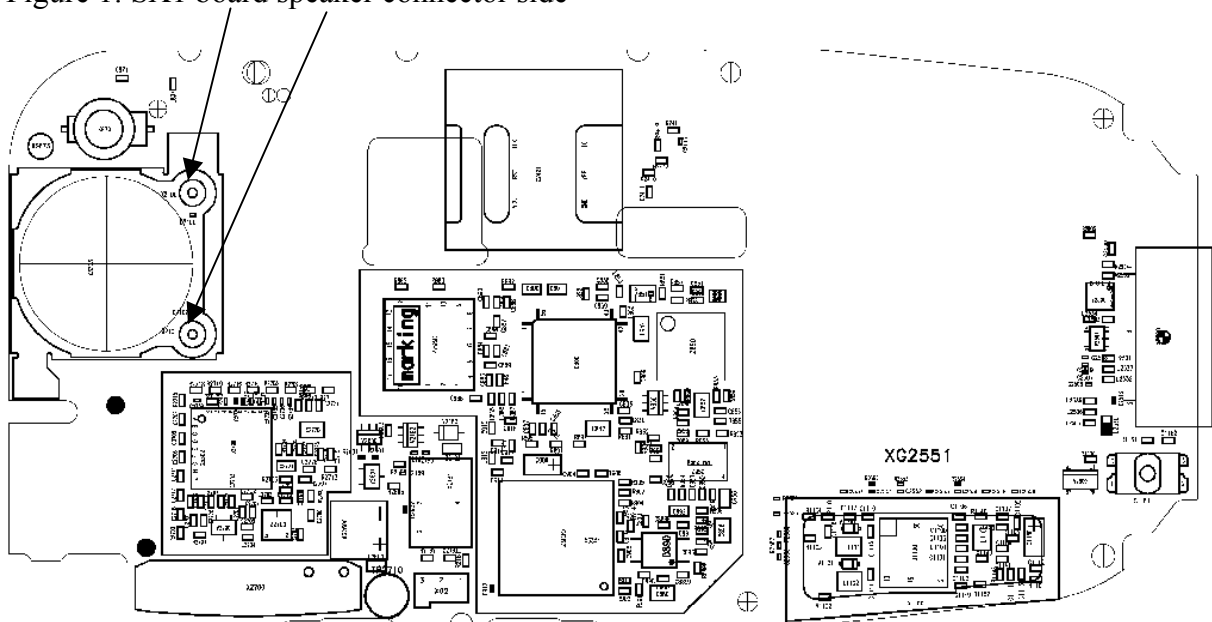
Figure 1: SX1 board speaker connector side

- Speaker malfunction

Visually check the status of the speaker connector. Watch for oxidation and dry solder joints.

Use soldering iron to remove defective connector.
Avoid excessive heat!

Resolder new connector afterwards.

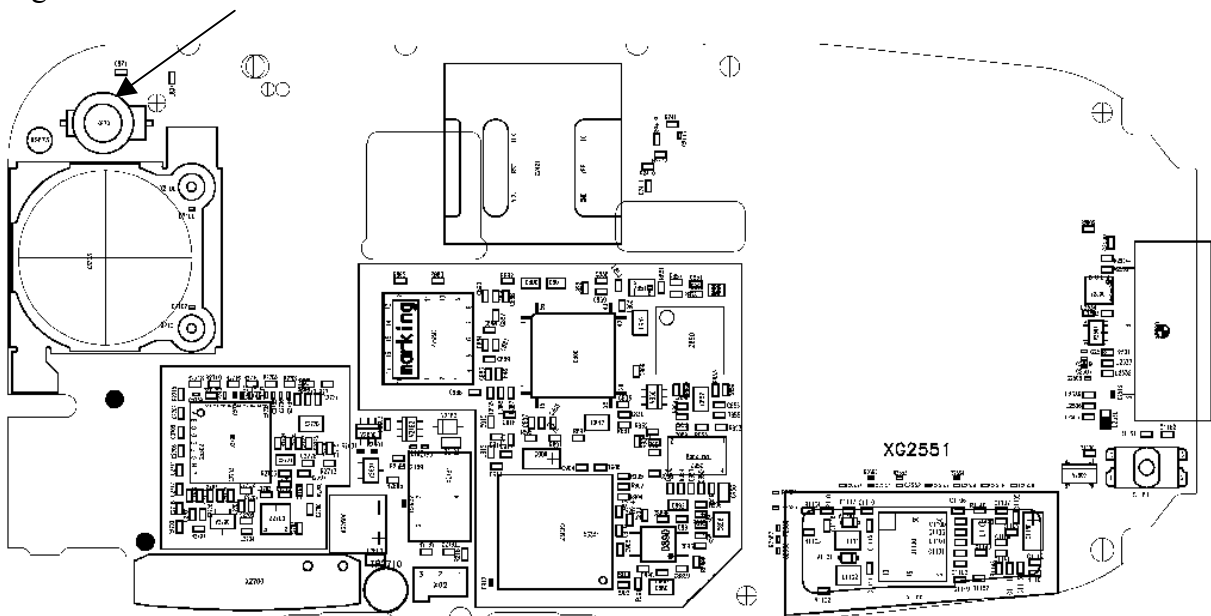
Figure 1: SX1 board Antenna connector

- Network Search
- No location update possible

Output power problems on the internal antenna
No location update possible

Use hot air blower remove defective antenna connector.
Avoid excessive heat!
Watch surrounding components!

Resolder new antenna connector afterwards.

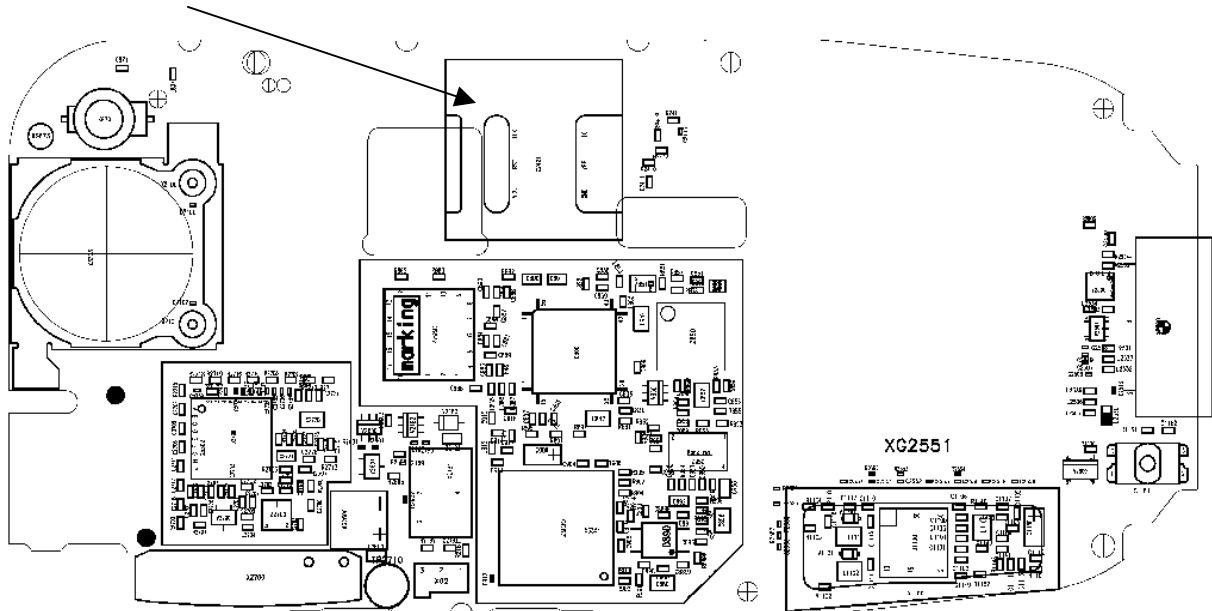
Figure 1: SX1 board Card Reader site

- Handset does not accept SIM.

Visually check the Card Reader. Watch for dry joints:

Use soldering iron to remove defective component.
Avoid excessive heat!
Watch surrounding components!

Resolder new Card Reader afterwards.

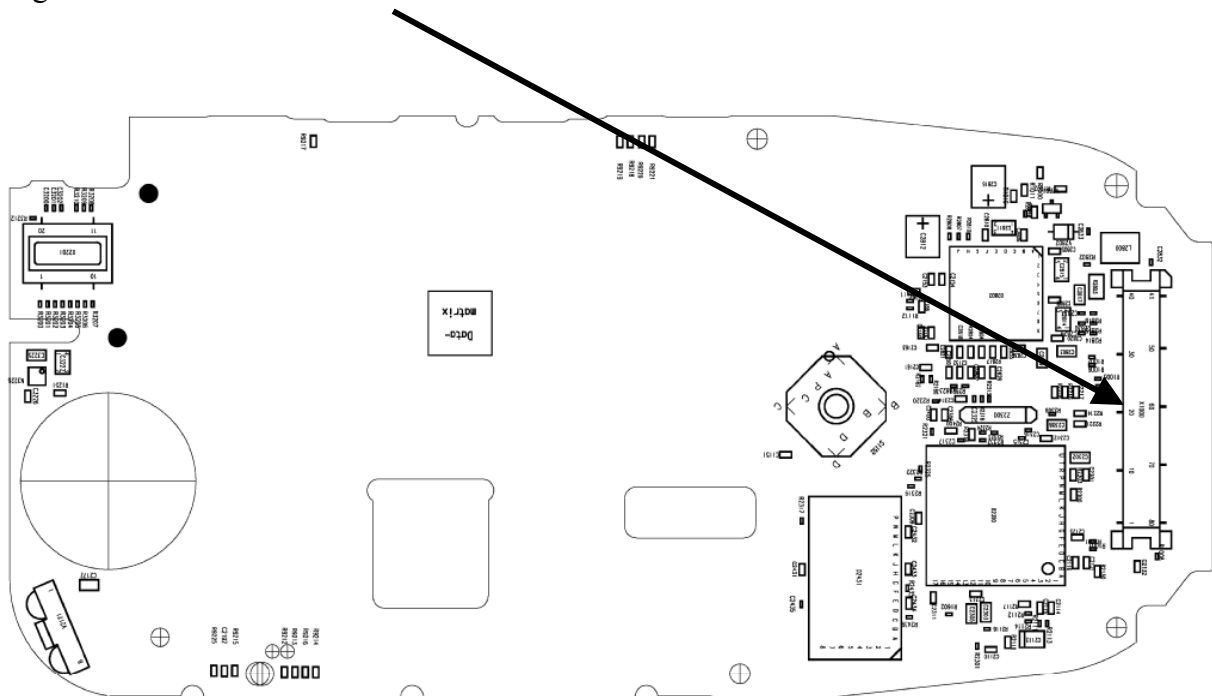
Figure 1: SX1 board MMI connector side

- Keyboard malfunction
- Illumination problems
- Display problems

Visually check the status of the MMI connector. Watch for oxidation and dry solder joints.

Use soldering iron to remove defective connector.

Resolder new connector afterwards.

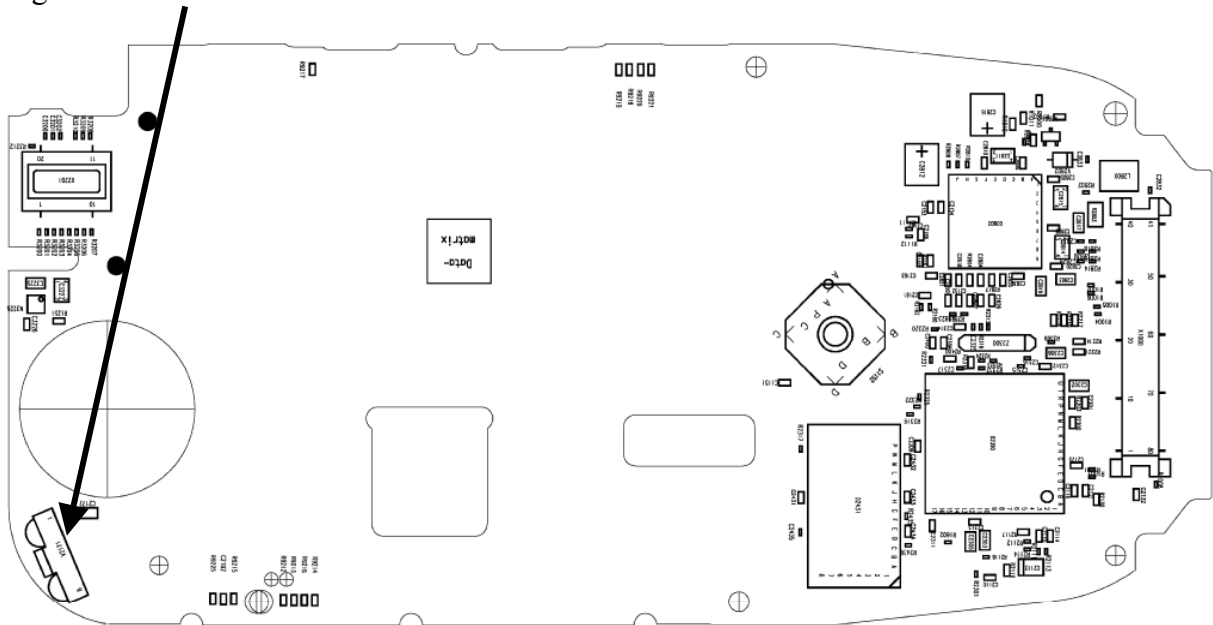
Figure 1: SX1 IRDA side

- No infrared connection possible

Use soldering iron to remove defective diode.

Resolder new diode afterwards.

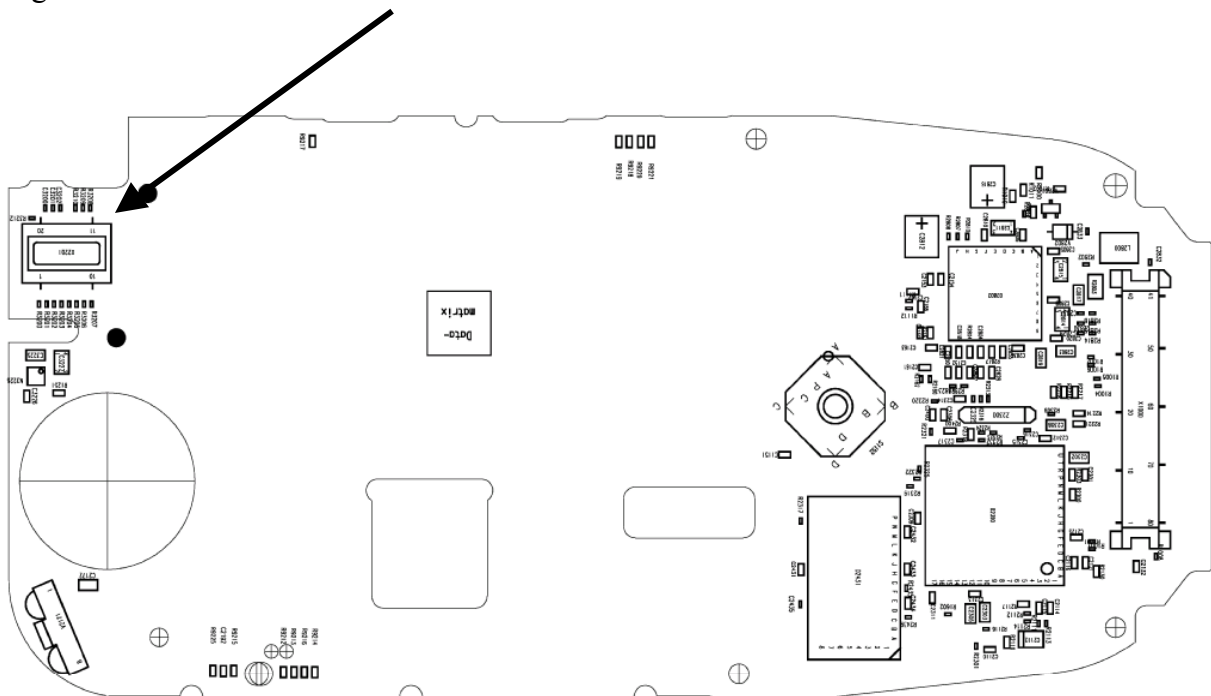
Figure 1: SX1 board camera connector side

- Problems with camera function.

Visually check the status of the camera connector. Watch for oxidation and dry solder joints.

Use soldering iron to remove defective connector.

Resolder new connector afterwards.

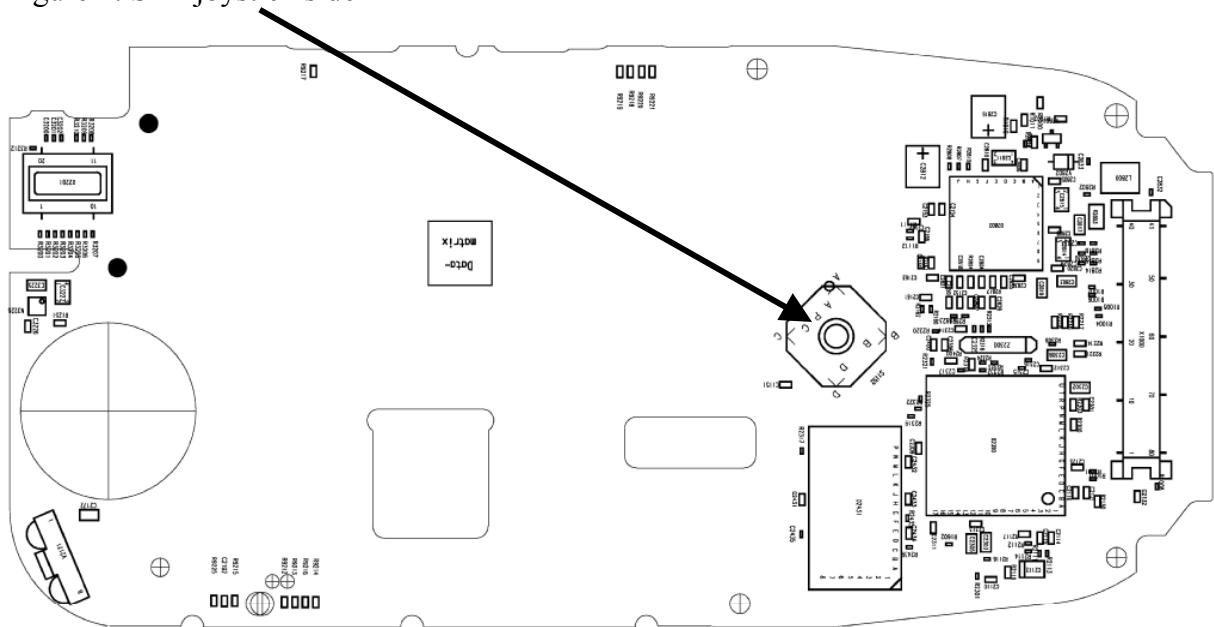
Figure 1: SX1 joystick side

- Problem with joystick function.

Visually check the status of the joystick. Watch for oxidation and dry solder joints.

Use soldering iron to remove defective joystick.

Resolder new joystick afterwards.

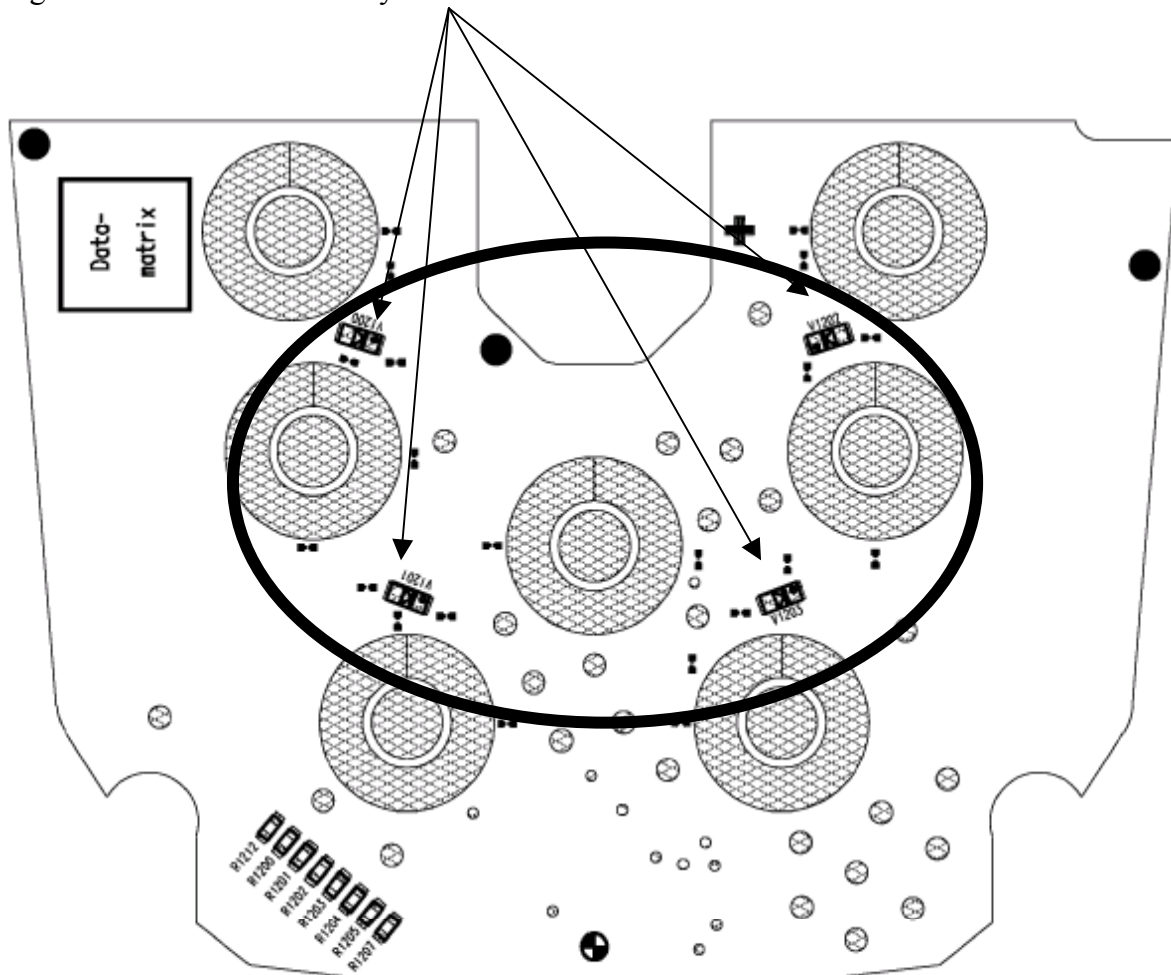
Figure 1: SX1 MMI board keyboard LEDs side

- Keyboard Illumination does not work

Use the diode test function of a multimeter to check the status of the diode. The typical voltage drop on the diode is 1.7V when testing the diode function with the multimeter

Use soldering iron to remove defective diode.
Avoid excessive heat!

Resolder new diode afterwards.

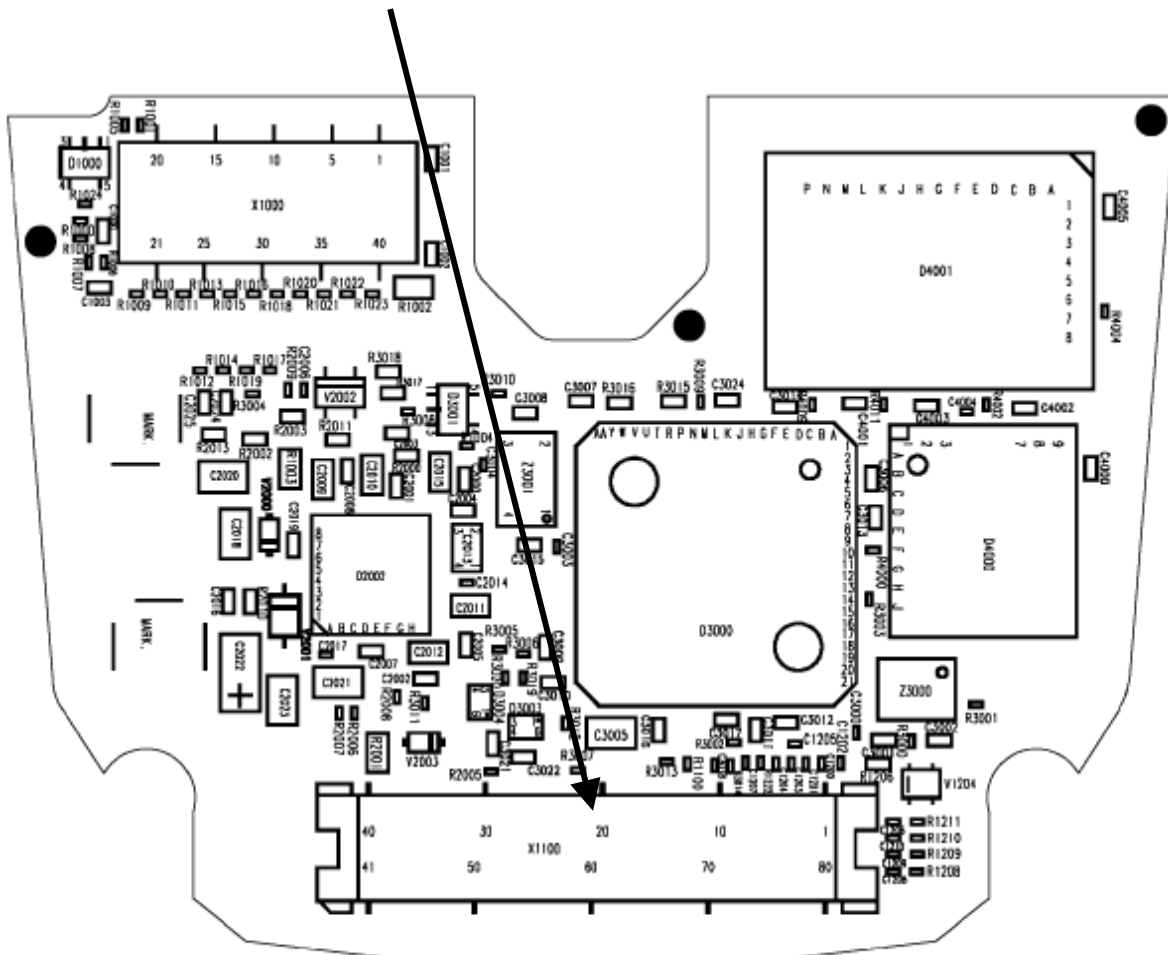
Figure 1: SX1 board MMI connector side

- Keyboard malfunction
- Illumination problems
- Display problems

Visually check the status of the MMI connector. Watch for oxidation and dry solder joints.

Use soldering iron to remove defective connector.

Resolder new connector afterwards.

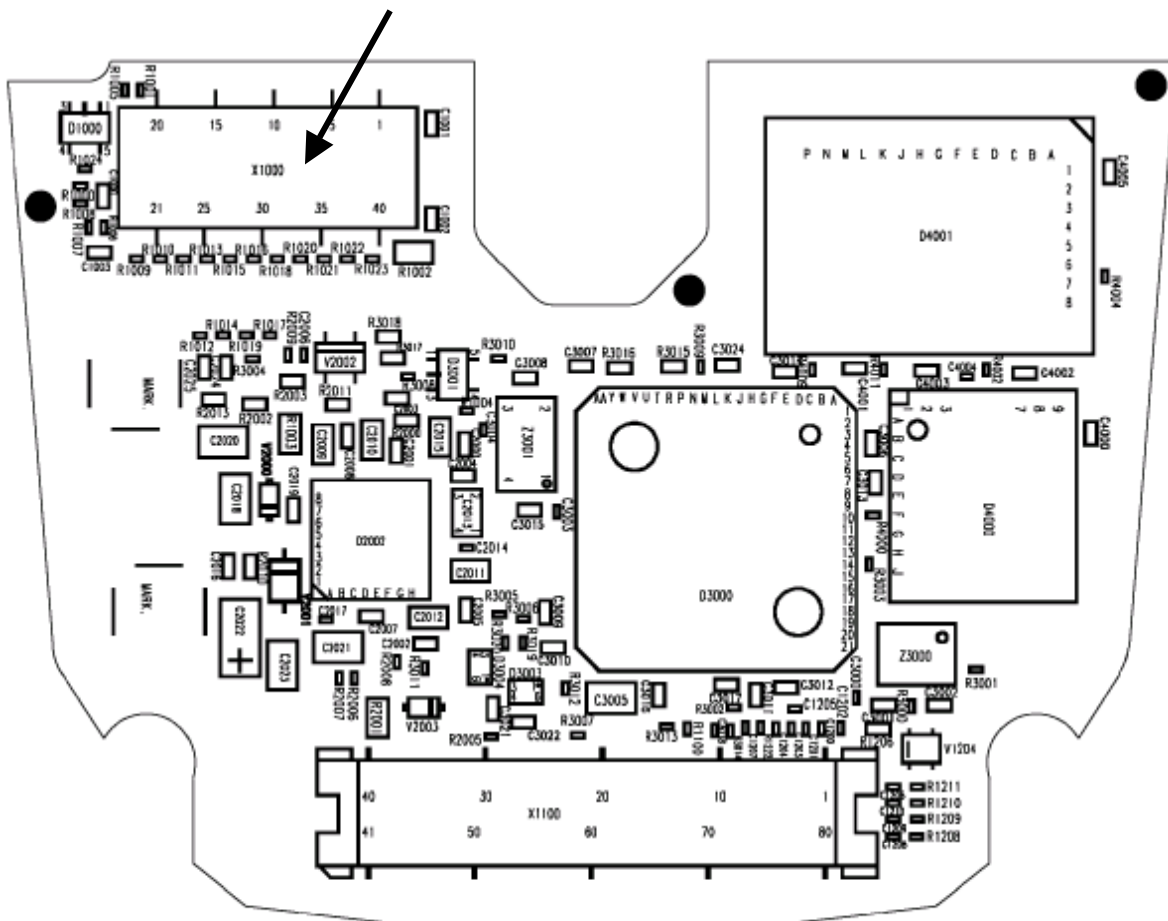
Figure 1: SX1 board display connector side

- Display Illumination problems
- Display problems

Visually check the status of the display connector. Watch for oxidation and dry solder joints.

Use soldering iron to remove defective connector.

Resolder new connector afterwards.
